When availability counts

Unwanted operation of protection equipment due to remanence in current transformers

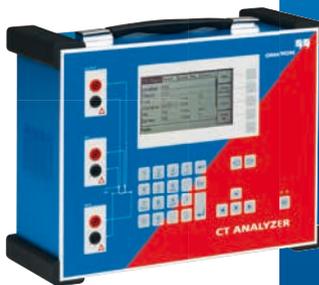
CT Analyzer

- > Highest measurement accuracy: 0.02% / 1 min when calibrating on site
- > Very small and lightweight (< 8 kg / 17.4 lbs), easy to transport for on-site testing
- > Automatic evaluation according to IEC and IEEE standards
- > Short commissioning times (duration of the automatic test < 1 min)
- > Excellent workplace safety – Tests run at max. 120 V
- > Integration into testing routines using Remote Interface Control

After completing the measurements in the field, the engineers from SBB demagnetized the current transformers using the CT Analyzer. This device proved extremely useful, as it completely demagnetizes the transformer core in an automated process following remanence measurement. Once all of the current transformers of machine 2 had been demagnetized in the Fall of 2012, no further false tripping was registered over an extended period
