Acoustic partial discharge localization with PDL 650 and MPD 600

New transformer with discharge noise

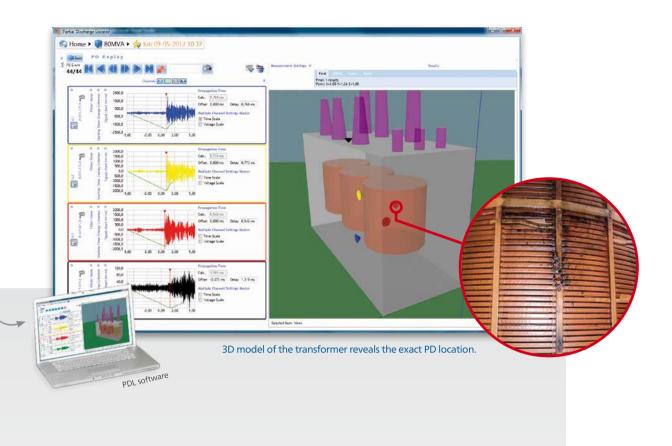
A newly manufactured 80 MVA, 240/135/16 kV transformer showed discharge noise while it was still in the factory. Acoustic PD detection was performed with OMICRON's PDL 650, connected to an MPD 600 PD analysis system and a PC. Specific PDL 650 sensors were placed at different positions on the transformer tank. The MPD 600 unit acted as trigger to start the acoustic signal acquisition with the PDL 650.

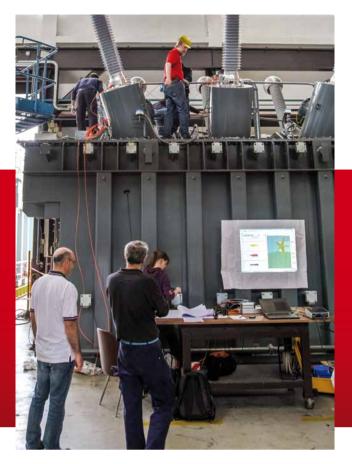
In order to allow the large group of attendees to follow the measurement more easily, the PC display was also projected on a provisory screen that was mounted to the transformer tank.
