Measurement, localization and monitoring of partial discharges on a power transformer

Case study – PD measurement on a 300 MVA oil-filled transformer

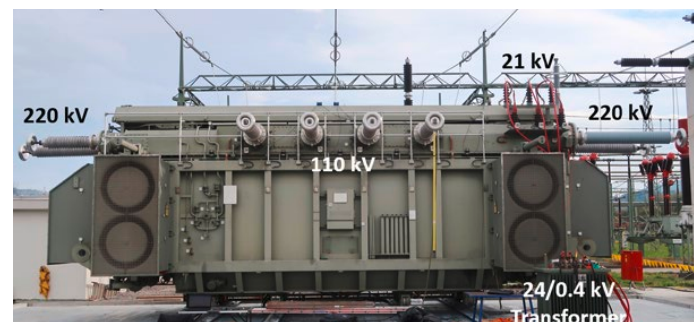
Fig. 1 shows the 300 MVA transformer with the horizontal 220 kV and 110 kV bushings and a small step-up transformer with 24/0.4 kV for exciting the 300 MVA transformer with a diesel-powered generator.

Figure 1
View of the 300 MVA Transformer

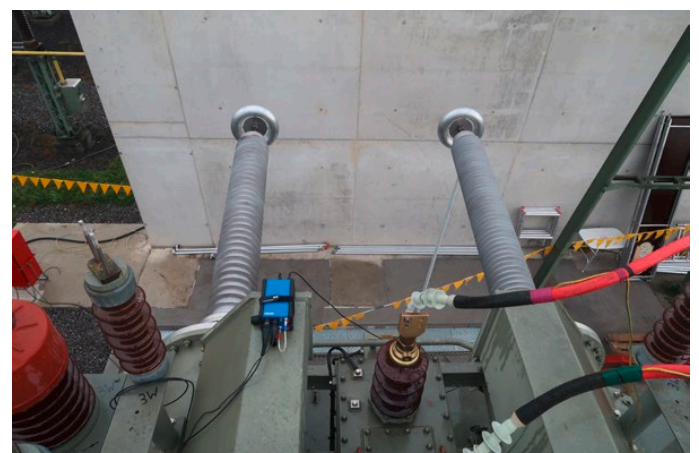
Figure 2
Setup for PD measurements on phases 1U and 1V

The test setup was performed in accordance with IEC 60270 [2], simultaneously decoupling the PD and AC signals at the measuring taps of all 220 kV and 110 kV bushings. Fig. 2 shows the setup of the MPD 800 PD detection instrument at the 220 kV bushings 1U and 1V. The signals of both bushing taps can be directly connected to one MPD 800 detector without using an additional coupling device. Fig. 3 shows the overall PD test setup.

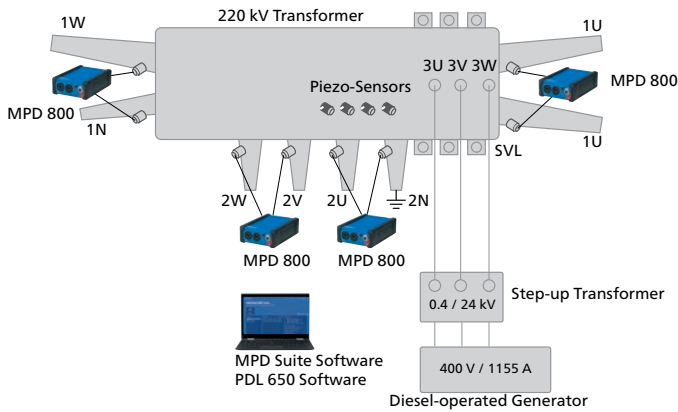
Figure 3
Setup for the PD measurements

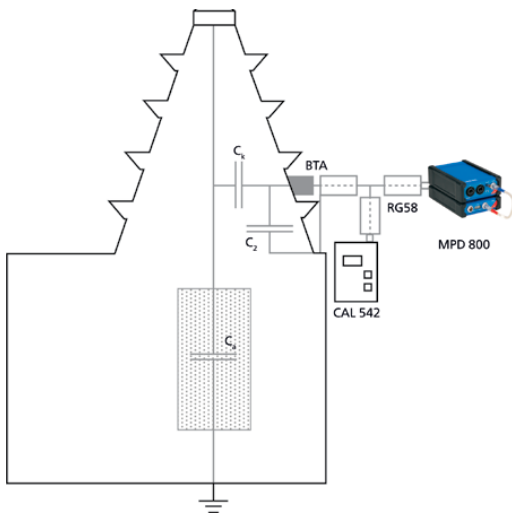
Figure 4
Artificial impulse injected directly at the bushing tap

A calibration signal was injected into all bushings, enabling the determination of a cross coupling matrix. In addition to the conventional PD calibration from HV to ground, a recording was also performed while injecting the calibrating signal into the measuring tap of the bushing to simulate a fault directly at the bushing tap. [1].

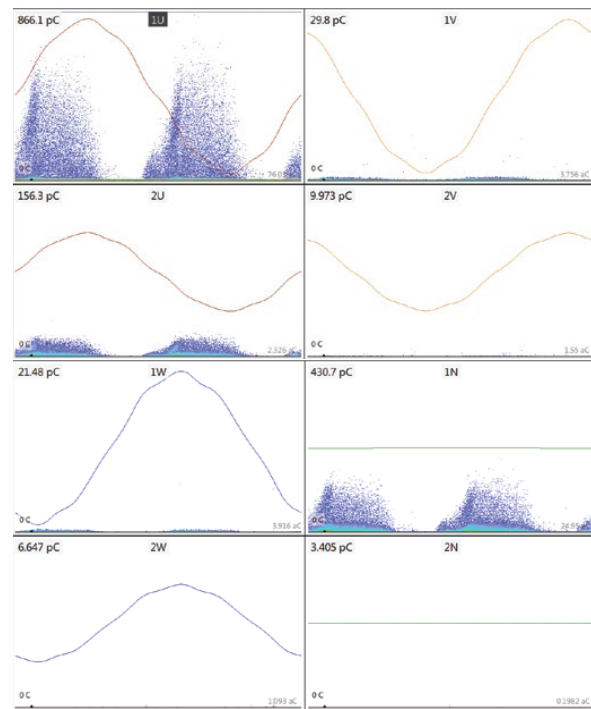
The ambient noise level was less than 10 pC at $0.5 \times U_n$ using a center frequency of 400 kHz and measuring bandwidth of 600 kHz. Even below the nominal voltage, partial discharges up to 2 nC could be detected at the measuring point 1U.

Figure 5
Phase Resolved PD (PRPD) pattern obtained at all measuring points at $0.8 \times U_n$, linear view

Comparing the charge values of the calibration cross coupling matrix with the cross coupling of the real PD activity indicated that the origin of the PD event is physically close to the measuring point 1U.

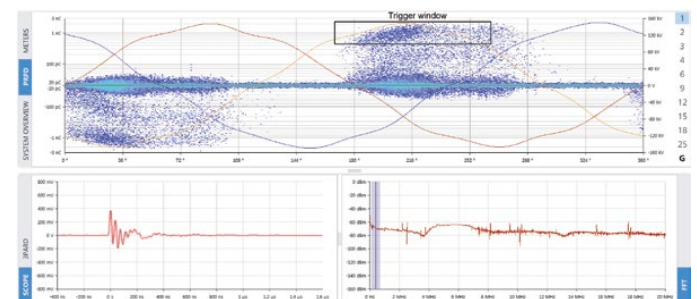
The MPD Suite software allowed the test engineers to draw a trigger window in the PRPD pattern. Only PD impulses occurring in the selected phase and amplitude area will trigger the scope and FFT view. This tool allows an easy comparison of the unfiltered high-frequency signals. Comparing the time signal and frequency spectrum of the signal directly injected at the bushing tap with the actual PD signal showed high similarities of their rise time and oscillation as well as resonances in the frequency spectrum. The frequency spectrum of the conventional calibration, where long cables had to be used, did not match.

Figure 6
MPD Suite software; logarithmic-bipolar view of the PRPD pattern at 1U, the trigger window and corresponding time and frequency signal

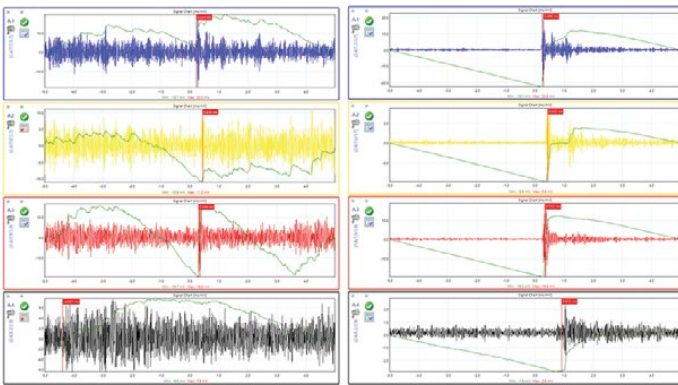
The MPD 800 PRPD window trigger also provides an electrical or optical output signal which can trigger an acoustical localization system. With this method the delay time to the different Piezo sensors can be measured absolutely referred to the electrical triggered PD impulse. This enables the use of averaging functions, which can result in a significantly improved signal-to-noise ratio. Fig. 7 shows the measured acoustic signals of the piezo sensors and the impact of averaging. The acoustic localization was performed with 8 piezo sensors installed in the area of phase 1U.

Figure 7
Acoustic signals without averaging (left) and the averaging of 100 events (right) using the electrical signal as trigger

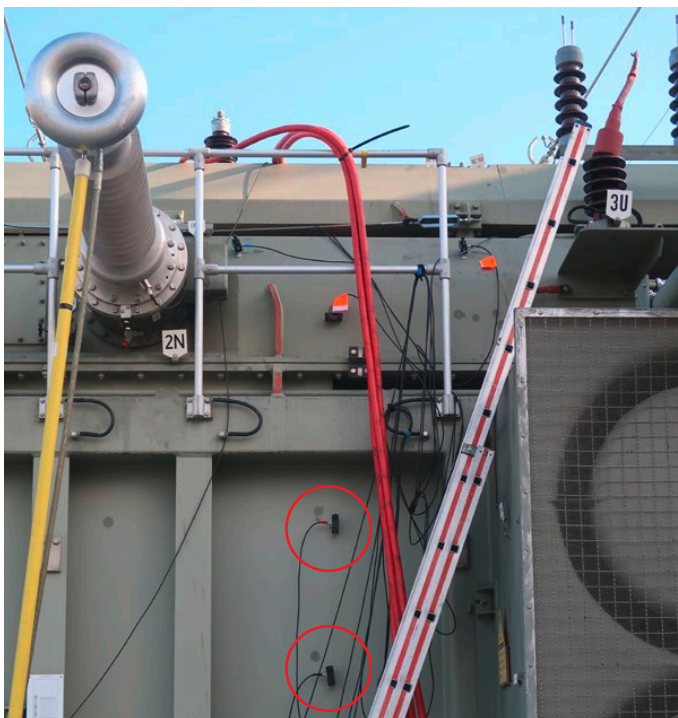
Figure 8
Installation of piezo sensors

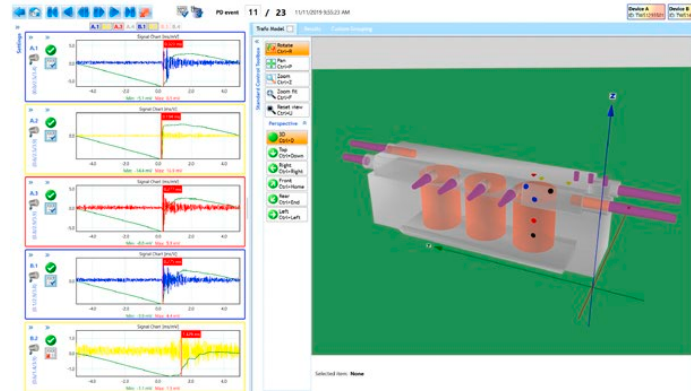
The triangulated fault position as well as the acoustic signal of the internal partial discharges is shown in Fig. 9 and Fig. 10. The location is close to the high-voltage exit lead of the 220 kV winding of phase 1U.

Figure 9
Acoustic signals of piezo sensors

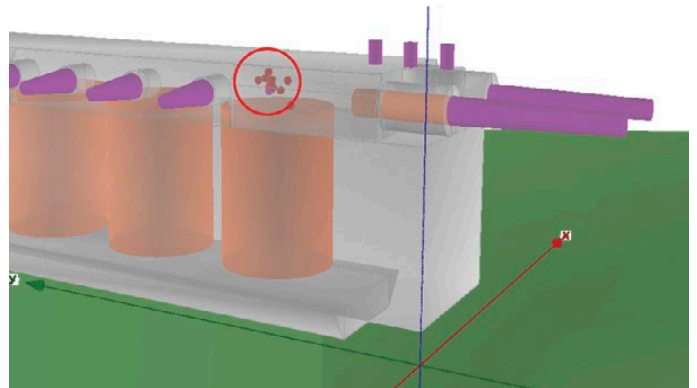
Figure 10
Location of PD at the high-voltage exit of phase 1U

Findings of the off-line PD measurement and localization were discussed with the transformer manufacturer. The fault location, PD behavior and the fact that it cannot be repaired on site led to the decision that the unit could be reenergized while carefully trending the PD activity as well as monitoring the gases dissolved in the insulation oil of the transformer.

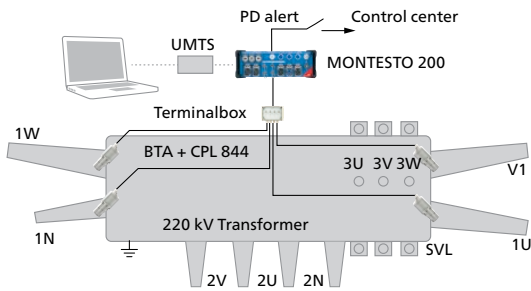
The transformer was then therefore equipped with bushing adapters at the bushing taps of all 220 kV bushings. The MONTESTO 200 PD monitoring and trending device used can be remotely controlled and communicates with the control center in case PD warning levels are exceeded.

Figure 11
Complete setup of the PD monitoring and trending system

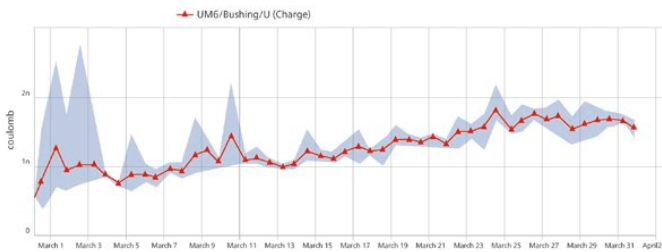
Audible corona discharge was active in the substation thus the measuring frequency was tuned to 2.2 MHz – a frequency range where the internal discharges dominated and external disturbances were minimized. The discharge level of the internal PD activity at Phase 1U was stable for the first weeks of operation, but then started to continuously increase over a period of one month. Fig. 12 shows the increasing trend of the apparent charge measured on Phase 1U.

Figure 12
Increasing PD trend on Phase 1U

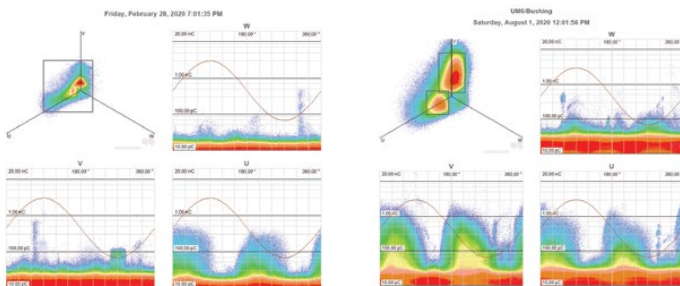
In addition to the known PD activity at Phase 1U a second pattern developed over 3 months, which started with approximately 100 pC and stabilized at 2 nC. The discharge pattern can be assigned to Phase 1V and shows high similarities to the phenomena obtained at 1U. The development of the PRPD pattern as well as the 3PARD diagram is shown in Fig. 13. Fig. 14 shows the development of the 3PARD filtered PRPD pattern obtained at Phase 1V.

Figure 13
Development of PD activity over a period of 5 months, logarithmic view

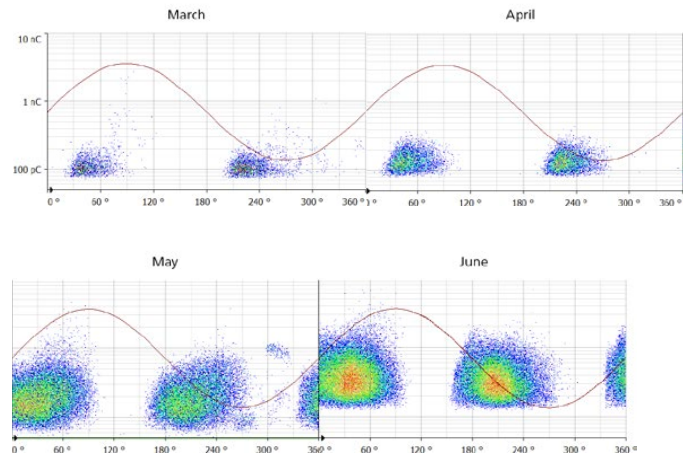
Figure 14
3PARD filtered PRPD pattern and development of the pattern obtained a Phase 1V

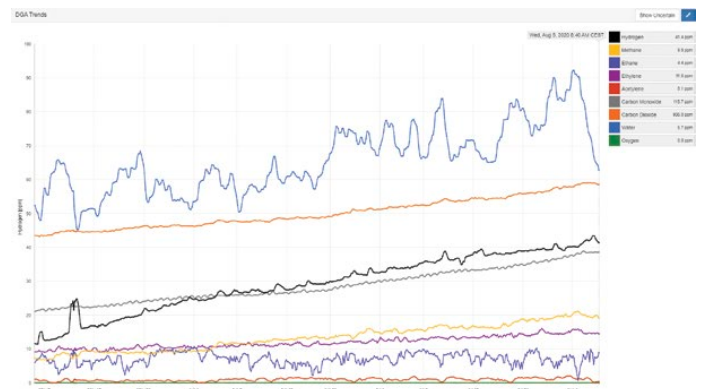
The DGA results before and after transportation did not indicate any failure nor PD activity. Hydrogen slightly increased during operation, but the overall amount of dissolved gases are below typical values, thus no reliable assessment can be performed [4]. A local defect inside a solid insulation part does not necessarily lead to an increase of dissolved gases.

Figure 15
DGA trend over 3 months
