Stator core condition assessment with CPC 100

The stray flux measurement with the CPC 100 is a reliable alternative, using a portable power source and measurement device that can be energized via an ordinary power plug. Beside the measurement at rated frequency, the CPC 100 allows you to excite the stator core at higher frequencies up to 400 Hz. The effect of the injection at different frequencies, detection of faults "deeper" in the core as well as the comparison to a ring flux measurement is explained in this paper.

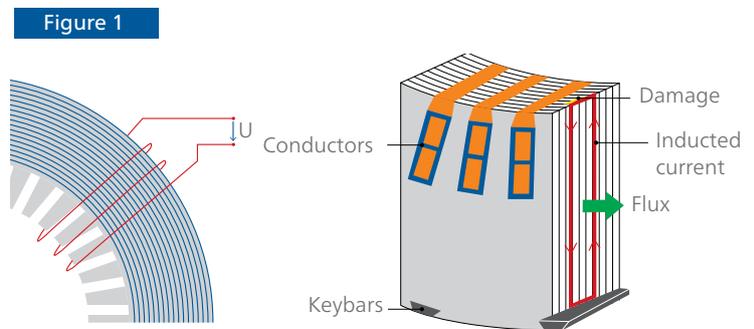
Figure 1
Left side: Auxiliary winding with indication of blue flux lines; Right side: higher eddy current due to a damage in the stator core.

To detect weak spots in the insulation of stator core segments, among other methods a stray flux measurement is used. In this case, a small percentage of the rated flux in the range of 2-10% is induced into the core via an auxiliary winding (Figure 1 left side) [1]. If a short between the lamination occurs, a higher eddy current – driven by the induced voltage from the auxiliary windings flux – causes a higher stray flux as shown in Figure 1 on the right side.

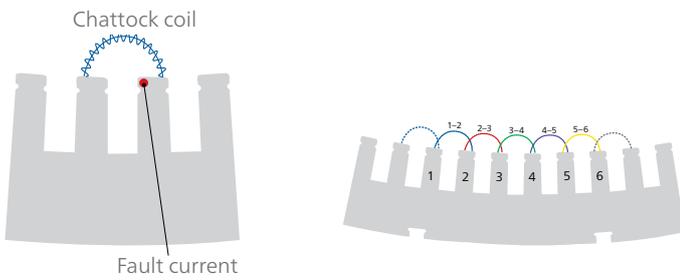
Figure 2

Detection of the fault current by measurement of the stray flux by the sensor. Different slots are sequentially scanned by different measurements. The coil span is between the teeth of one slot to the next slot to ensure a certain overlapping area.

This is detected as a higher stray flux by a Chaddock for Rogowski coil scanning the stator surface as explained in Figure 2. [3] The readings of the coil are in mA correlated to a certain position within the stator core. As the measurement coil width and the number of turns of the sensor remains the same for each measurement, a calibration can be obtained prior to each measurement.

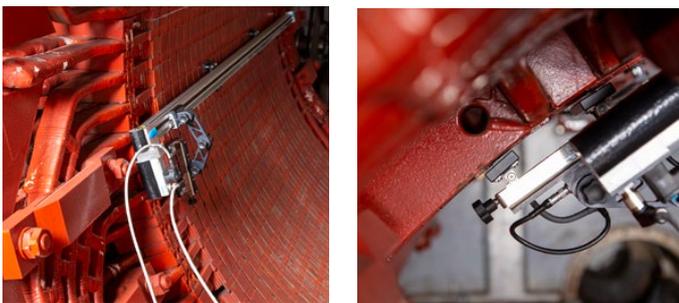
Figure 3

Rail and coil support during a measurement

Knowing that a manual measurement can be cumbersome and time-consuming, the intention was to increase the usability as much as possible. Therefore, a semi-automatic movement of the sensor comes with the stray flux measurement solution. The rail (RAA1) enables this movement and is placed with strong magnets onto the stator core. Additional fall arresters ensure that the rail cannot fall once positioned and damage any devices.

The sensor on the slide travels over the stator surface at a distance of between 2-3 mm, which ensures a sensitive measurement. Furthermore, no spikes are present in the results from the ventilation ducts or other unevenness if the coil support is not touching the surface.

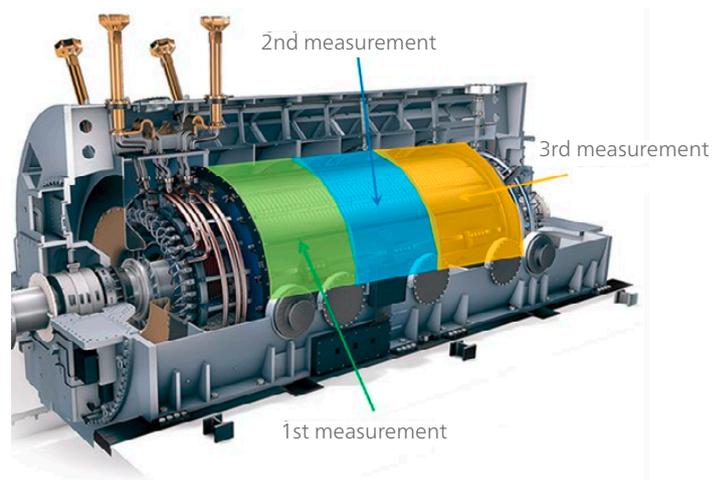
Figure 4

Measurement approach if long stators need to be scanned; Picture-Source Generator: Siemens

The maximum length the rail can cover is 1760 mm. Longer stators can be measured as well, as the results of the different measurement methods can be combined in the software. The recommended approach in this case is to divide the stator in segments and measure each segment, as explained in Figure 4.

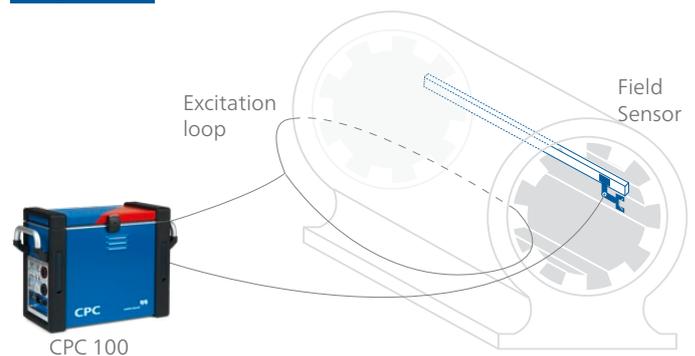
Figure 5

Simplified schematic of the CPC 100 as both an excitation and a measurement device

The required power of less than 3 kVA enables the CPC 100 to act as a source and measurement device in one solution. Even higher excitation power, also from the output of an ordinary power plug, is possible, as the excitation is only active when the rail is moving. Together with the rail (RAA1), the control unit (SCU1) and the winding multiplier (WMP1), users have all they need to perform the measurement.

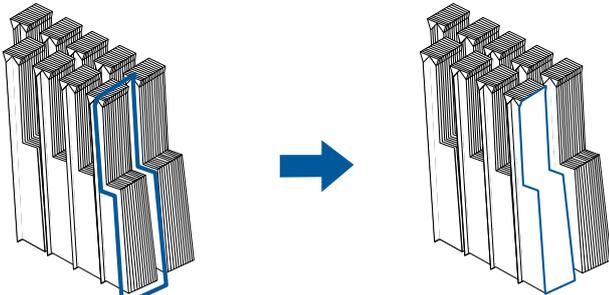
Figure 6

Explanation of the implementation of an artificial fault. A wire is wrapped around a core segment and shorted afterwards (left). Electrically this can be seen equal to a core segment without laminations (right).

The investigations regarding the reproducibility of the measurement results as well for a better visibility of the effect of different excitation frequencies, the experiments on the small hydro generator have been carried out with a measurement over an artificial fault. A stator segment is shorted by a wire as explained in Figure 6. The reason for this modification is that it is an easier modification with the wire over two ventilation ducts rather than damaging the stator core.

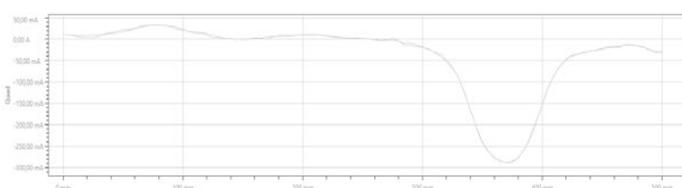
Two measurements of the same slot

In order to be sure that the often-used interpretation limit is not influenced by the measurement setup, investigations on the reproducibility have been performed. This becomes even more important, as the user wants to have a trending over time, to estimate the criticality of existing potential weak spots. The first comparison in Figure 7 shows two measurements on the same slot with a fault in it, without changing any setting.

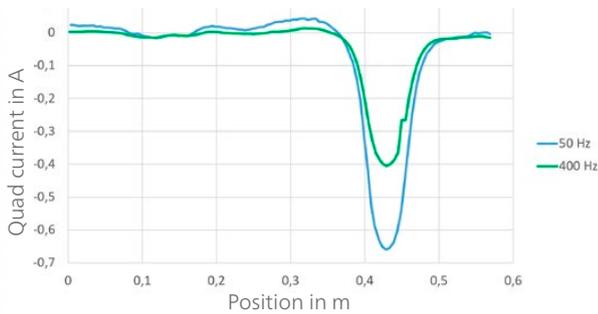
Figure 9

Measurement with the same excitation voltage

If measured with 0,5% of rated flux at 400 Hz, the highest peak at the defect has an absolute amplitude value of around 400 mA, while at 4% and 50 Hz the peak reaches around 650 mA (Figure 9). Although this is much lower, it needs to be considered, the flux was decreased by the factor of 8 (!).

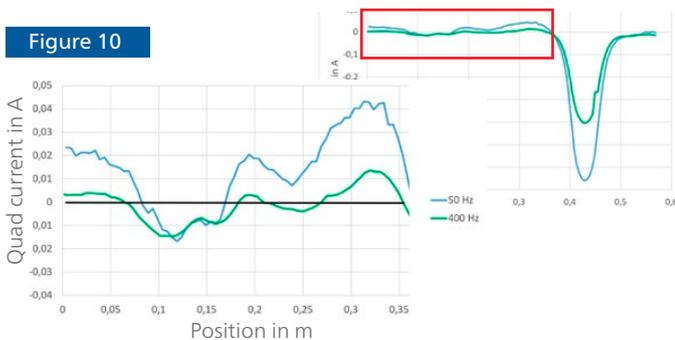
Figure 10

Zoom out of the slot section without the fault

Furthermore, we see a lower fluctuation as well around the zero line of the 400 Hz measurement when looking at the "healthy" section of the slot (Figure 10).

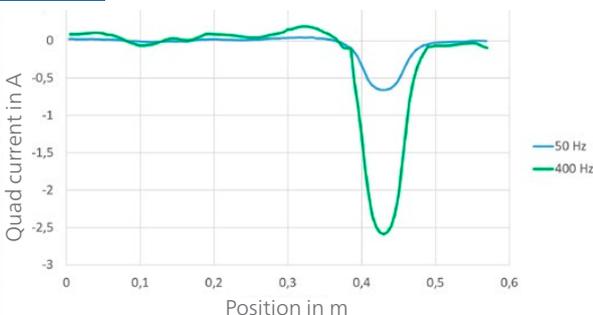
Figure 11

Measurement with the same flux; please note the different scaling at the vertical axis compared to Figure 9.

As already assumed from the first experiment, when keeping the flux equal for both frequencies, the picture changes completely, as displayed in Figure 11. . In this case, the amplitude of the 400 Hz measurement is much higher than the 50 Hz measurement at the fault. When comparing this with the measurement in Figure 9, please be aware of the different scaling on the vertical axis.

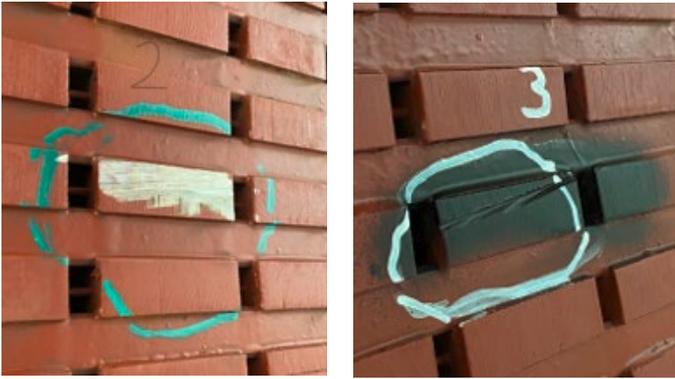
Example of the fault implementation and black painting to avoid reflection during thermographic measurement.

Figure 13 shows the implementation of these faults, exemplarily on two spots. Different ways of implementing have been tried out.

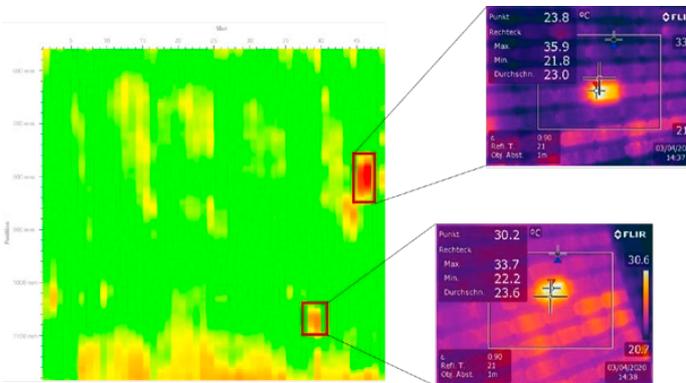
Heat map of the stray flux measurement including thermographic pictures of the comparison measurement with full flux. The two locations with higher temperature raise could be as well identified in the stray flux measurement, where both spots had an amplitude of higher than 100 mA.

Intuitive real-time signal display and a summary of the measurement by help of a heat map as shown in Figure 14

Depending on the modification technique, not every spot shows a significant increase, for example in temperature raise during the full flux test, as well in the stray flux measurement. Two modifications showed a temperature raise of >10 °C compared to the surrounding, which is considered as critical [1]. These locations could be reliably detected with the stray flux measurement and an amplitude higher than 100 mA too. The heat map with the results of the entire stator as well as the thermographic picture of the two critical spots is displayed in Figure 14. The other spots showed less temperature increase compared to the surroundings. They have been visible as well in the stray flux measurement, as locations with higher stray flux, but remained below the limit of 100 mA.
