Technical Paper

The Value of Performing Power Factor Sweep Measurements on Bushings – Revision #1 (Oct. 2018)

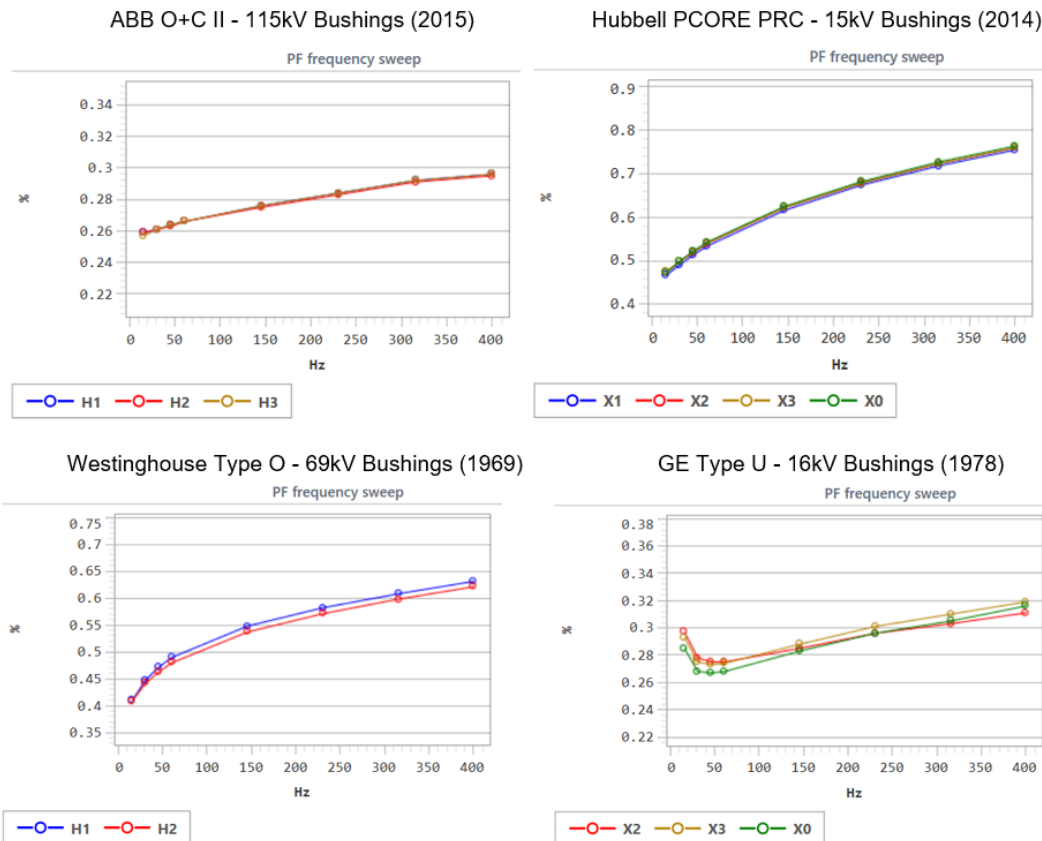
The C1 Power Factor frequency-sweep measurements for four different sets of similar-unit bushings are provided in Figure 1. Notice that the shape of the traces is similar when comparing the similar-unit bushings. Also, for all the traces in Figure 1, the measured Power Factor increases versus frequency (from left-to-right), which is typically indicative of healthy insulation.

Figure 1 – Acceptable C1 Power Factor Frequency Sweep Traces

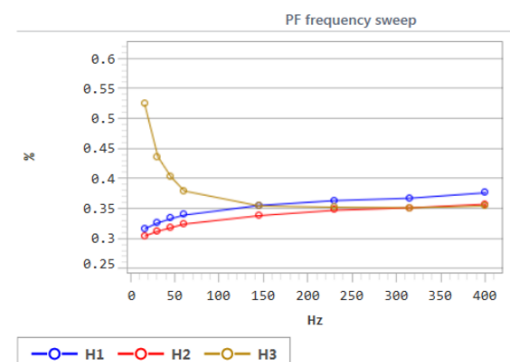
HAEFELY 115kV Bushings (2000)				
	2kV Power Factor	10kV Power Factor	10kV PF – 2kV PF	Nameplate Power Factor
H1	0.34%	0.34%	0.00%	0.38%
H2	0.32%	0.32%	0.00%	0.37%
H3	0.38%	0.41%	0.03%	0.35%
*Note, the measured capacitance for each bushing compared well to its respective nameplate value

Figure 2 – C1 Power Factor Results for Three Haefely 115kV Bushings

Based on the results in Figure 2, the 10kV Power Factor for H3 is higher than its nameplate value, whereas the 10kV Power Factor for the other two bushings is below their respective nameplate values. Also, notice that the 2kV and 10kV Power Factor measurements for the H3 bushing are dissimilar. In contrast, the 2kV and 10kV Power Factor measurements for the H1 and H2 bushings are reasonably similar, which further suggests that the H3 measurements are abnormal.

When comparing the Power Factor frequency sweep traces amongst similar-unit bushings, the shape of the traces should be reasonably similar. Clearly, the shape of the H3 trace is dissimilar relative to the traces of the other two bushings. Moreover, the H3 trace decreases versus frequency, and has the distinctive “fish-hook” in the lower frequency range, which is typically indicative of compromised insulation.

Interestingly, the 10kV Power Factor for H3 is below 1.5-to-2 times its nameplate value, which the industry generally considers to be acceptable [1]; however, the H3 bushing is clearly behaving differently than the other two, similar bushings, which is cause for concern. This case demonstrates that the Power Factor sweep measurements are more sensitive to compromised insulation than the conventional 10kV Power Factor measurement. The H3 bushing should be flagged as the weak link among the three bushings, and if returned to service, should be tested more-frequently to ensure that its insulation does not rapidly fail.

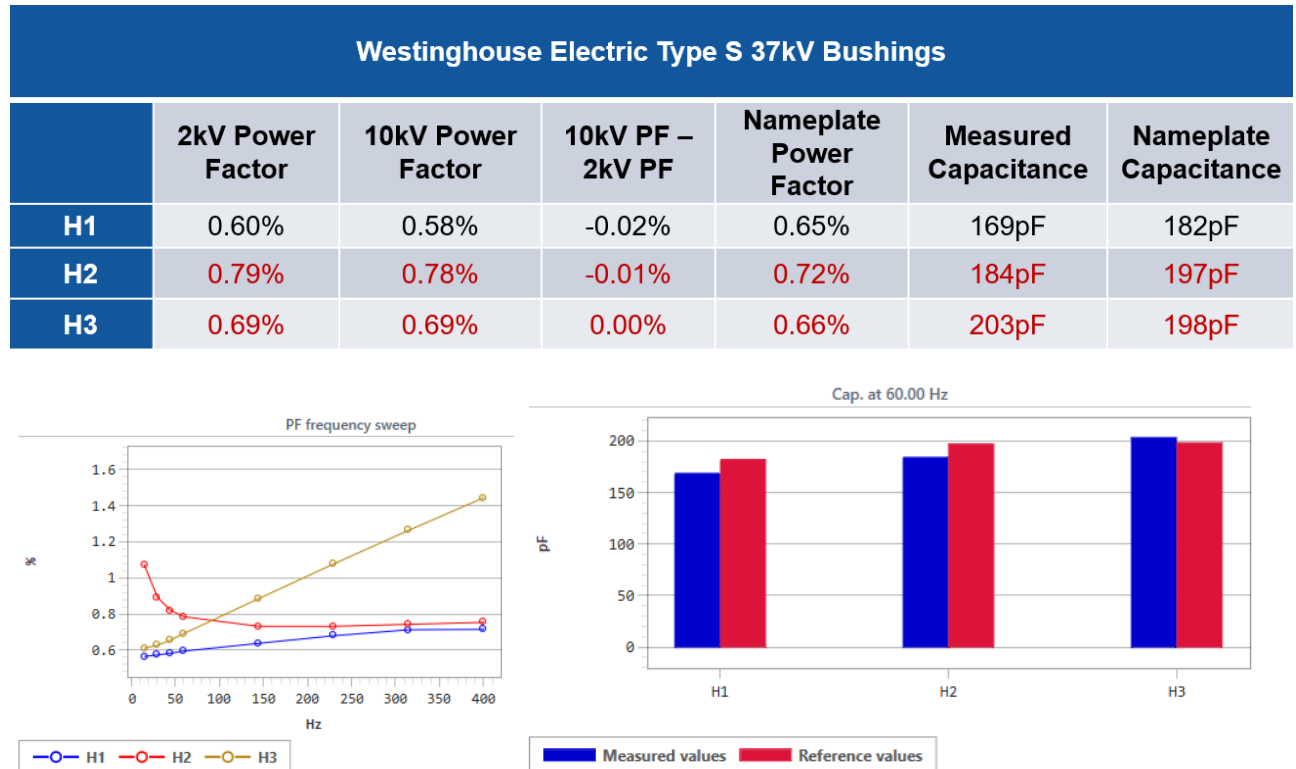
Figure 4 - C1 Power Factor Results for Three Westinghouse Type-S 37kV Bushings

This case is particularly interesting, because it provides an example of three sister-unit bushings that produced three completely different Power Factor frequency sweep traces. The Power Factor frequency sweep trace for the H1 bushing is a “typical” example of a trace produced by a “healthy” bushing, whereas the Power Factor frequency sweep trace for the H2 bushing is a “typical” example of a trace produced by a questionable bushing; however, the Power Factor frequency sweep trace for the H3 bushing is an example of an “abnormal” or “non-typical” frequency sweep trace, which warrants concern.

Although I cannot provide a definitive conclusion to the specific issue, based on experience, there appears to be a bushing insulation failure mode, where the measured Capacitance (pF) value of the bushing is significantly different, relative to its nameplate value, and relative to the other sister-unit bushings. For this type of insulation failure, in addition to the measured Capacitance (pF) value being different than expected, the Power Factor frequency sweep trace becomes more-or-less linear, and exhibits a steep incline, from left-to-right (as demonstrated by the H3 bushing in Figure 4). In addition to this case, it appears that this same phenomenon is demonstrated by Case Study #19 and Case Study #20.

Interestingly, in this case, and in Case Study #20, the bushings that tested with a measured Capacitance (pF) value that is significantly different than expected, tested with a relatively low, “normal” 60Hz Power Factor value. Concluding, if the measurements provided in Figure 4 can be verified, then the insulation system of the H3 bushing has failed, and if returned to service, should be tested more-frequently to ensure that its insulation does not rapidly fail.

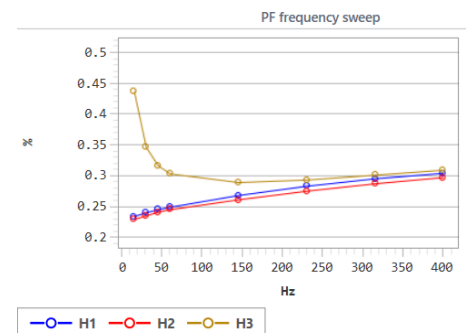
ABB O+C 115kV Bushings (1992)				
	2kV Power Factor	10kV Power Factor	10kV PF – 2kV PF	Nameplate Power Factor
H1	0.25%	0.25%	0.00%	0.26%
H2	0.24%	0.24%	0.00%	0.24%
H3	0.30%	0.31%	0.01%	0.25%

Figure 7 - C1 Power Factor Results for Three ABB O+C 115kV Bushings

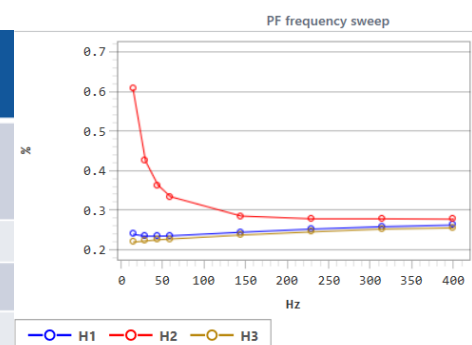
ABB O+C 142kV Bushings (2010)				
	2kV Power Factor	10kV Power Factor	10kV PF – 2kV PF	Nameplate Power Factor
H1	0.24%	0.24%	0.00%	0.26%
H2	0.33%	0.36%	0.03%	0.26%
H3	0.23%	0.23%	0.00%	0.24%

Figure 8 - C1 Power Factor Results for Three ABB O+C 142kV Bushings

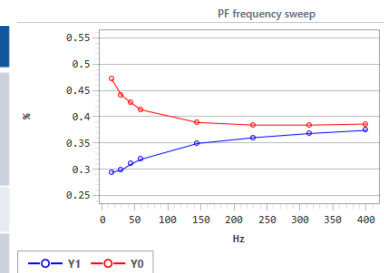
GE Type-U 16kV Bushing (1964)				
	2kV Power Factor	10kV Power Factor	10kV PF – 2kV PF	Nameplate Power Factor
Y1	0.32%	0.32%	0.00%	-
Y0	0.41%	0.44%	0.03%	-

Figure 9 - C1 Power Factor Results for Two GE Type-U 16kV Bushings

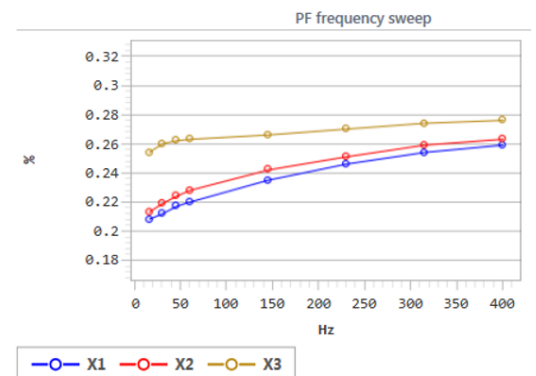
ABB O+C 72kV Bushings (2012)				
	2kV Power Factor	10kV Power Factor	10kV PF – 2kV PF	Nameplate Power Factor
X1	0.22%	0.22%	0.00%	0.25%
X2	0.23%	0.23%	0.00%	0.24%
X3	0.26%	0.28%	0.02%	0.24%

Figure 10 – C1 Power Factor Results for Three ABB O+C 72kV Bushings

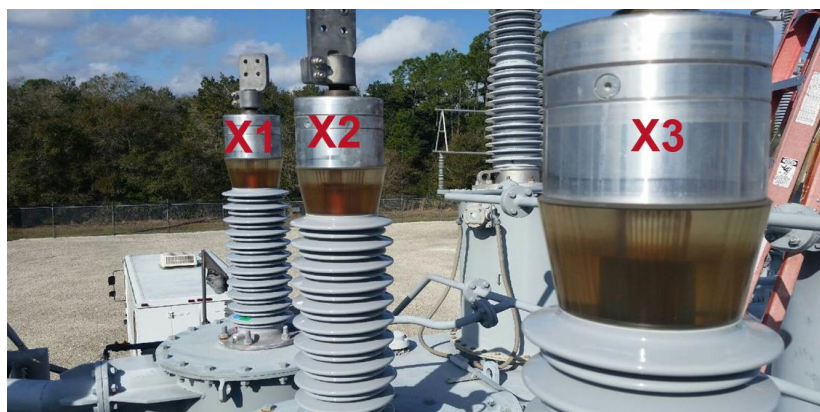
Figure 11 – Sight Glass Comparison for the Three ABB O+C 72kV Bushings

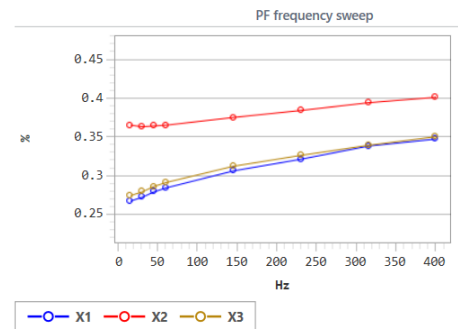
ABB O+C 25kV Bushings (1992)				
	2kV Power Factor	10kV Power Factor	10kV PF – 2kV PF	Nameplate Power Factor
X1	0.29%	0.31%	0.02%	0.31%
X2	0.36%	0.41%	0.05%	0.30%
X3	0.29%	0.31%	0.02%	0.31%

Figure 12 - C1 Power Factor Results for Three ABB O+C 25kV Bushings

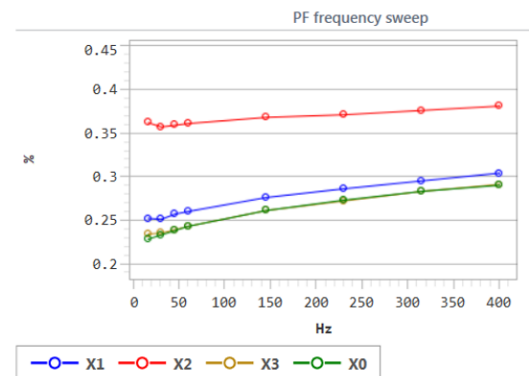
ABB O+C 25kV Bushings (1992)				
	2kV Power Factor	10kV Power Factor	10kV PF – 2kV PF	Nameplate Power Factor
X1	0.26%	0.29%	0.03%	0.29%
X2	0.36%	0.41%	0.05%	0.25%
X3	0.24%	0.26%	0.02%	0.28%
X0	0.24%	0.26%	0.02%	0.27%

Figure 13 - C1 Power Factor Results for Three ABB O+C 25kV Bushings

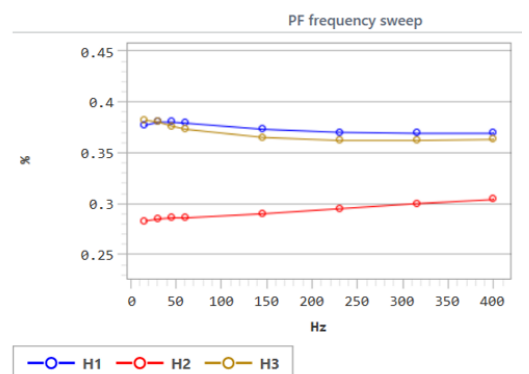
ABB O+C 69kV Bushings				
	2kV Power Factor	10kV Power Factor	10kV PF – 2kV PF	Nameplate Power Factor
H1	0.38%	0.41%	0.03%	-
H2	0.29%	0.31%	0.02%	-
H3	0.37%	0.43%	0.06%	-

Figure 14 - C1 Power Factor Results for Three ABB O+C 69kV Bushings

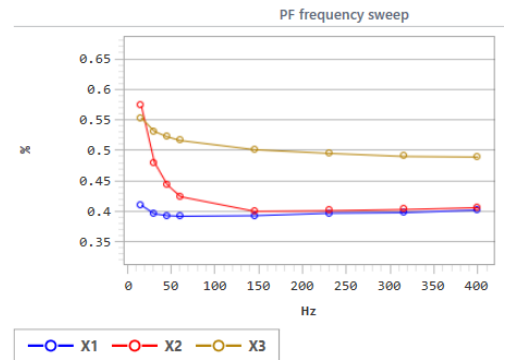
ABB O+C 34.5kV Bushings (1998)				
	2kV Power Factor	10kV Power Factor	10kV PF – 2kV PF	Nameplate Power Factor
X1	0.39%	0.42%	0.03%	0.25%
X2	0.42%	0.48%	0.06%	0.25%
X3	0.52%	0.61%	0.09%	0.31%

Figure 15 - C1 Power Factor Results for Three ABB O+C 34.5kV Bushings

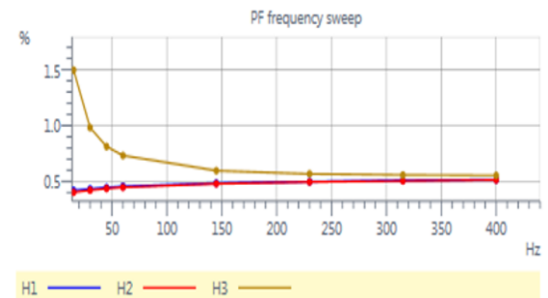
McGraw Edison 69kV Bushings (1979)				
	2kV Power Factor	10kV Power Factor	10kV PF – 2kV PF	Nameplate Power Factor
H1	0.46%	0.46%	0.00%	0.51%
H2	0.45%	0.45%	0.00%	0.50%
H3	0.73%	0.78%	0.05%	0.50%

Figure 16 - C1 Power Factor Results for Three McGraw Edison 69kV Bushings

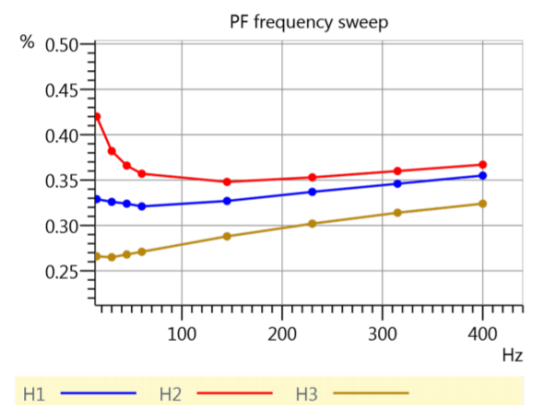
VTC 69kV Bushings (2009) – Note, only H2 and H3 are similar-unit bushings				
	2kV Power Factor	10kV Power Factor	10kV PF – 2kV PF	Nameplate Power Factor
H1	0.32%	0.32%	0.00%	0.31%
H2	0.36%	0.37%	0.01%	0.25%
H3	0.27%	0.27%	0.00%	0.25%

Figure 17 - C1 Power Factor Results for Three VTC 69kV Bushings

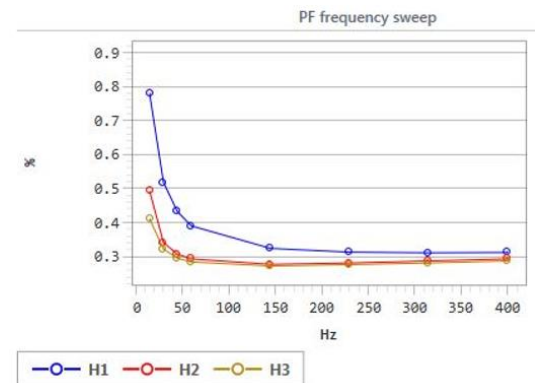
GE Type-U 69kV Bushings (1985)				
	2kV Power Factor	10kV Power Factor	10kV PF – 2kV PF	Nameplate Power Factor
H1	0.45%	0.55%	0.10%	0.28%
H2	0.34%	0.36%	0.02%	0.27%
H3	0.33%	0.35%	0.02%	0.27%

Figure 18 - C1 Power Factor Results for Three GE Type-U 69kV Bushings

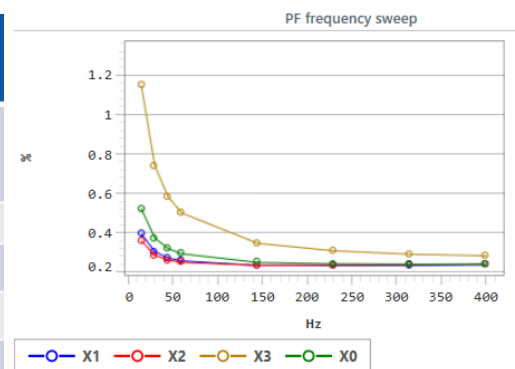
PCORE OIP 24.9kV Bushings (2013)				
	2kV Power Factor	10kV Power Factor	10kV PF – 2kV PF	Nameplate Power Factor
X1	0.26%	0.26%	0.00%	0.23%
X2	0.25%	0.25%	0.00%	0.23%
X3	0.50%	0.57%	0.07%	0.23%
X0	0.29%	0.29%	0.00%	0.23%

Figure 19 - C1 Power Factor Results for Three PCORE OIP 24.9kV Bushings

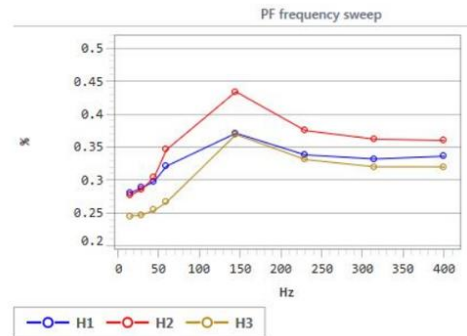
VTC 69kV Bushings (2009)				
	2kV Power Factor	10kV Power Factor	10kV PF – 2kV PF	Nameplate Power Factor
H1	0.32%	0.36%	0.04%	0.31%
H2	0.36%	0.44%	0.08%	0.25%
H3	0.27%	0.30%	0.03%	0.25%

Figure 23 - C1 Power Factor Results for Three VTC 69kV Bushings

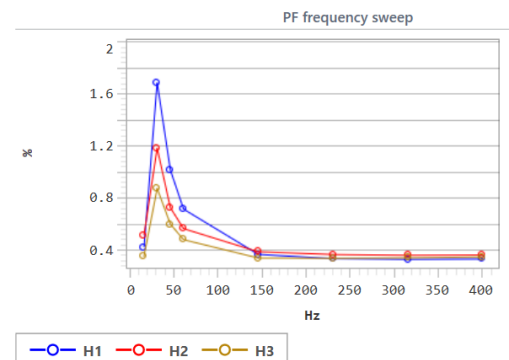
GE Type-U 230kV Bushings (1983)				
	2kV Power Factor	10kV Power Factor	10kV PF – 2kV PF	Nameplate Power Factor
H1	0.72%	0.53%	-0.19%	0.27%
H2	0.57%	0.48%	-0.09%	0.29%
H3	0.48%	0.41%	-0.07%	0.28%

Figure 24 - C1 Power Factor Results for Three GE Type-U 230kV Bushings

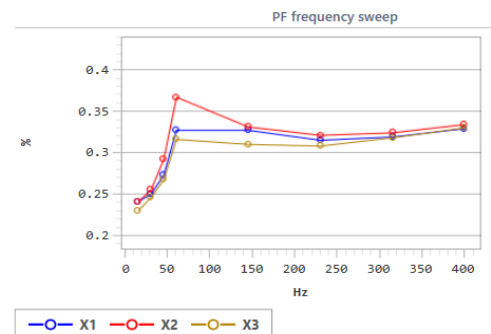
GE Type U 150kV Bushings (1983)				
	2kV Power Factor	10kV Power Factor	10kV PF – 2kV PF	Nameplate Power Factor
X1	0.32%	0.37%	0.05%	0.30%
X2	0.37%	0.37%	0.00%	0.29%
X3	0.32%	0.35%	0.03%	0.29%

Figure 25 - C1 Power Factor Results for Three GE Type U 150kV Bushings

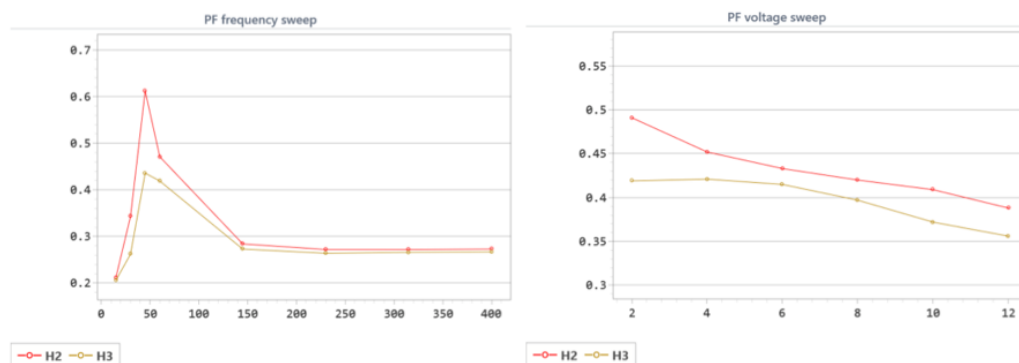
ABB 115kV Bushings (2016)				
	2kV Power Factor	10kV Power Factor	10kV PF – 2kV PF	Nameplate Power Factor
H1	-	-	-	0.25%
H2	0.47%	0.40%	-0.07%	0.25%
H3	0.42%	0.37%	-0.05%	0.25%

Figure 26 - C1 Power Factor Results for Three ABB 115kV Bushings

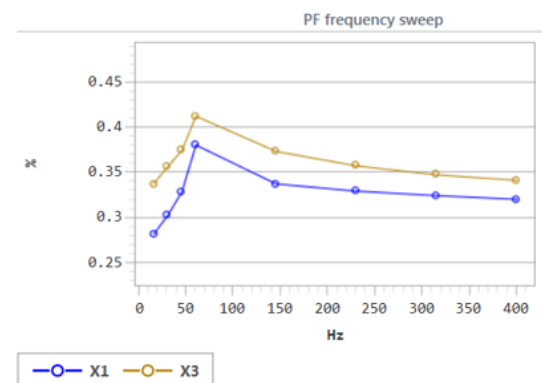
Figure 27 - C1 Power Factor Results for Three Lapp POC 72.5kV Bushings
