# Bushing Power Factor Testing: In-Depth

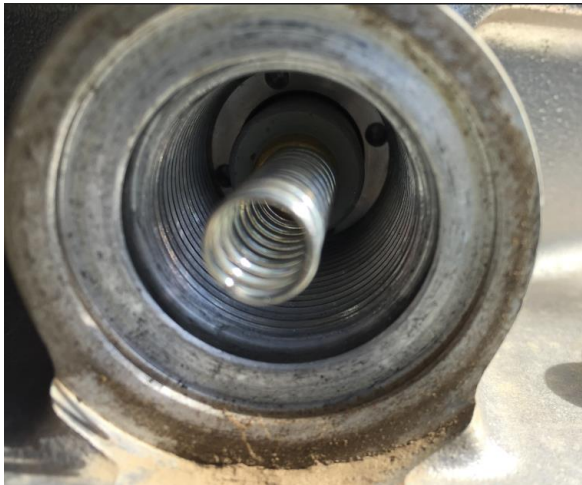
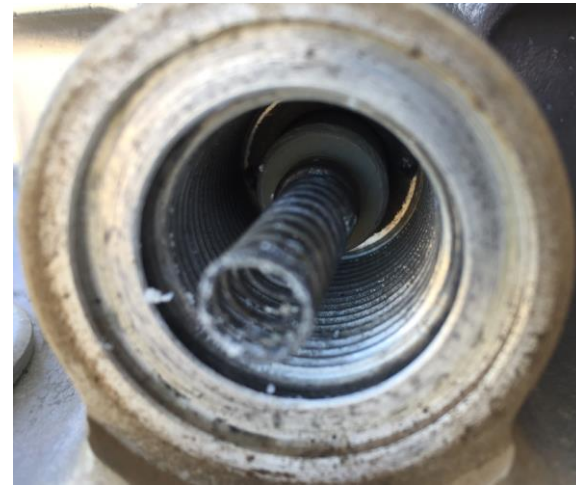
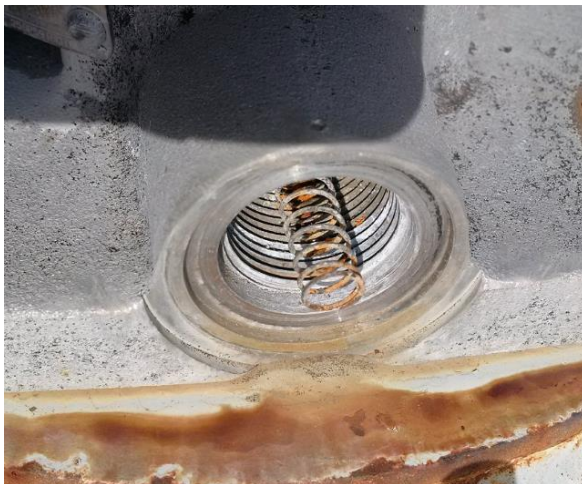
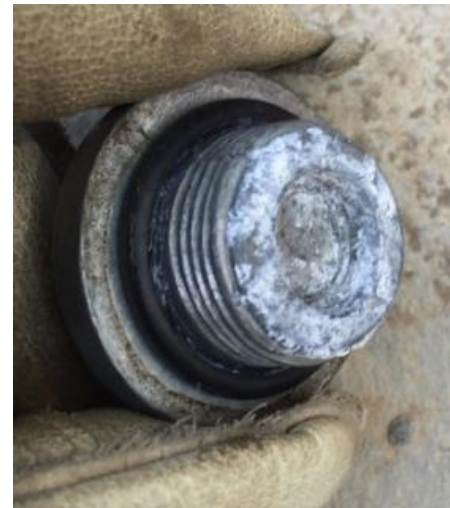
## Bushing Taps and “Tap Cap”

- Bushings rated  $\leq 350\text{kV}$  BIL have test taps
- Tap grounded in service
- C2 test voltage typically 500V
- C2 Cap  $\approx$  C1 Cap  $\approx 200 - 500\text{pF}$
- Bushings rated  $> 350\text{kV}$  BIL have potential taps
- Tap grounded in-service or used as a supply
- C2 test voltage typically 2000V
- C2 Cap  $\gg$  C1 Cap
- C2 Cap  $\approx 2000-5000\text{pF}$

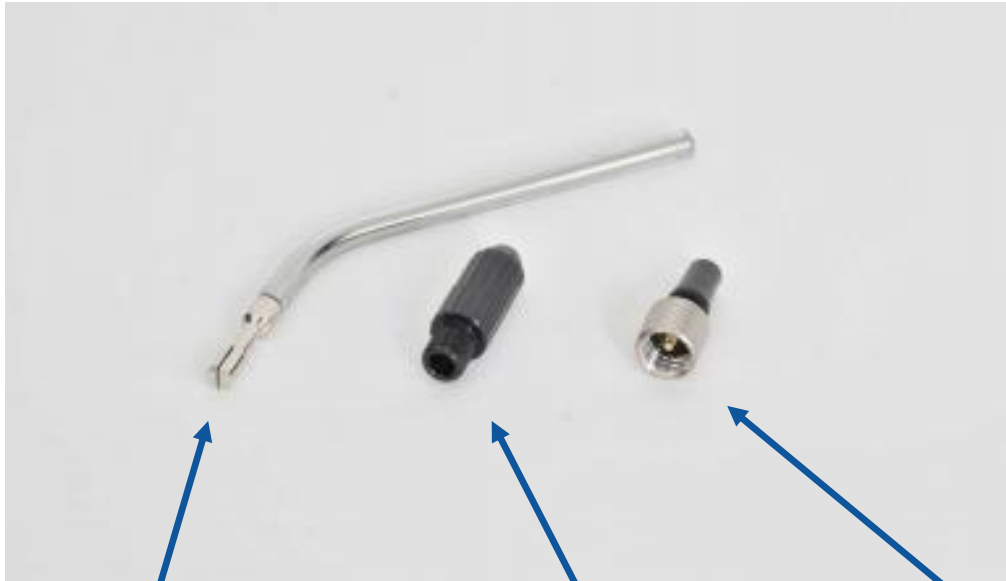
# Bushing Power Factor Tap Adapters

Westinghouse Type O  
(hockey stick)

Westinghouse Type OS, S

ASEA GO Types

Westinghouse O Plus

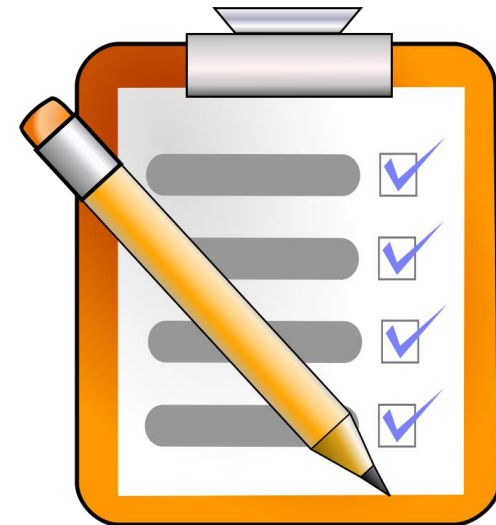
- The Power Factor measurement is highly sensitive, and is one of the most difficult measurements to “get right” (i.e. to perform correctly)
- The “**Power Factor checklist**” is a series of steps that must be observed, when performing a Power Factor measurement on an insulation system, to ensure that the correct measurement is obtained
- Failure to observe all the steps in the “**Power Factor checklist**” often results in “bad” Power Factor measurements (i.e. invalid Power Factor measurements)

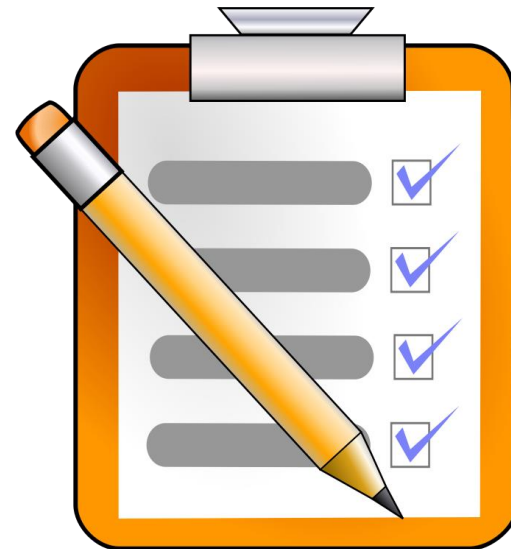
- ☐ Do not Power Factor test in the rain
- ☐ Avoid testing in high-humidity situations
- ☐ Do not Power Factor test when the temperature of the oil is close-to, or below, 5°C
- ☐ Power Factor test after lunch, if possible

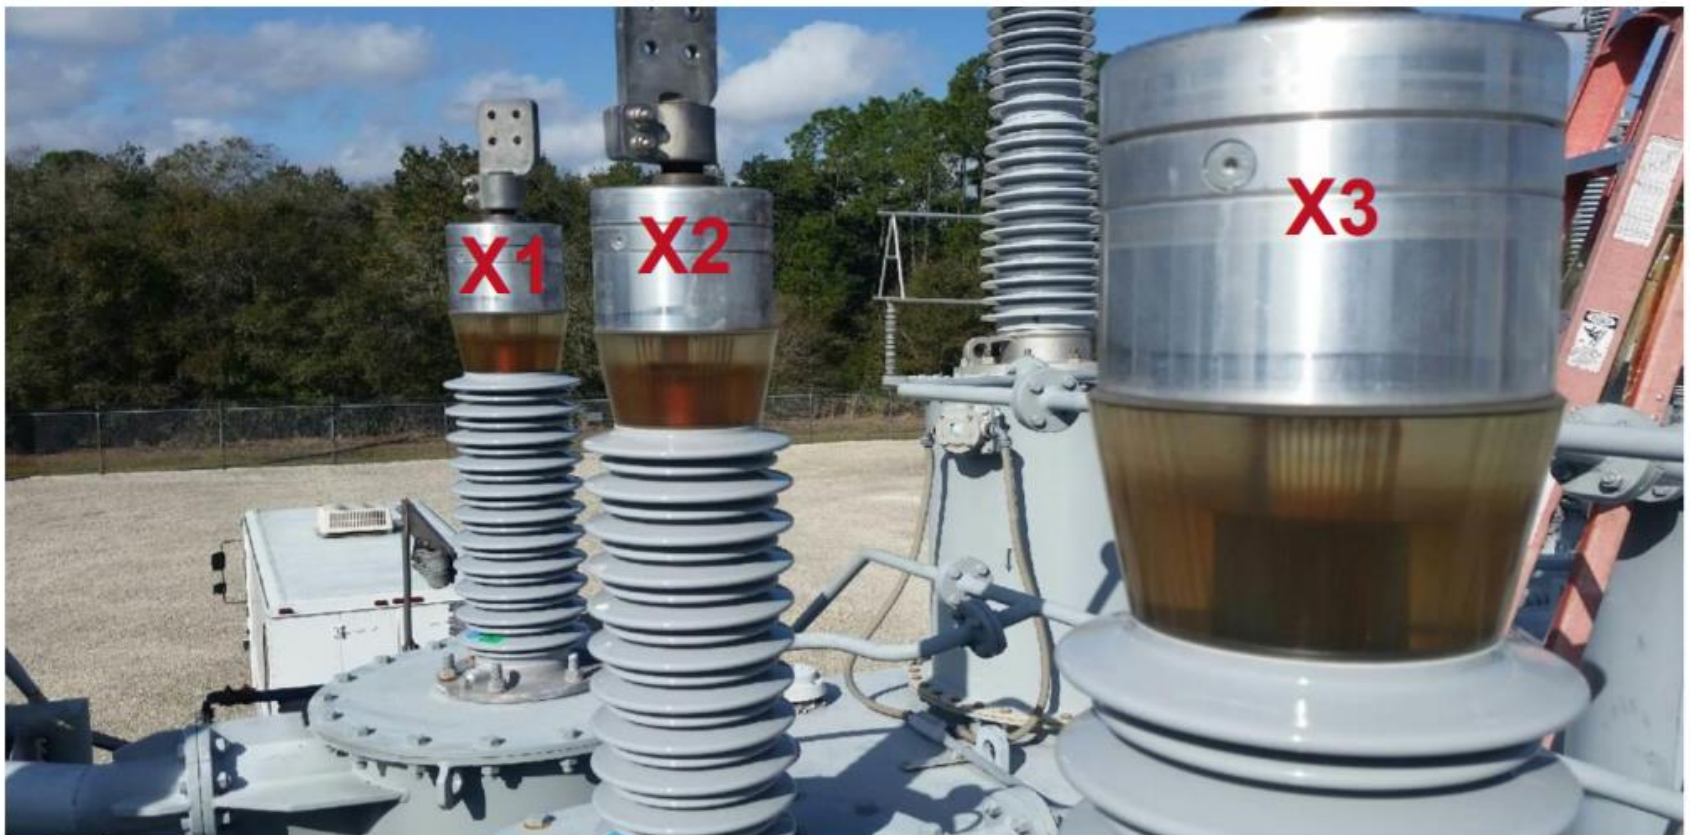
# Questionable Bushing C1 Power Factor Measurements

ABB O+C 72kV Bushings (2012)				
	2kV Power Factor	10kV Power Factor	10kV PF – 2kV PF	Nameplate Power Factor
X1	0.22%	0.22%	0.00%	0.25%
X2	0.23%	0.23%	0.00%	0.24%
X3	0.26%	0.28%	0.02%	0.24%

“Our preliminary observation/evaluation is that the X3 bushing is loose to the point of arcing and heating the conducting bushing rod”
