# Current Peaks Investigated

Effects on grid quality with decentralized feed-in

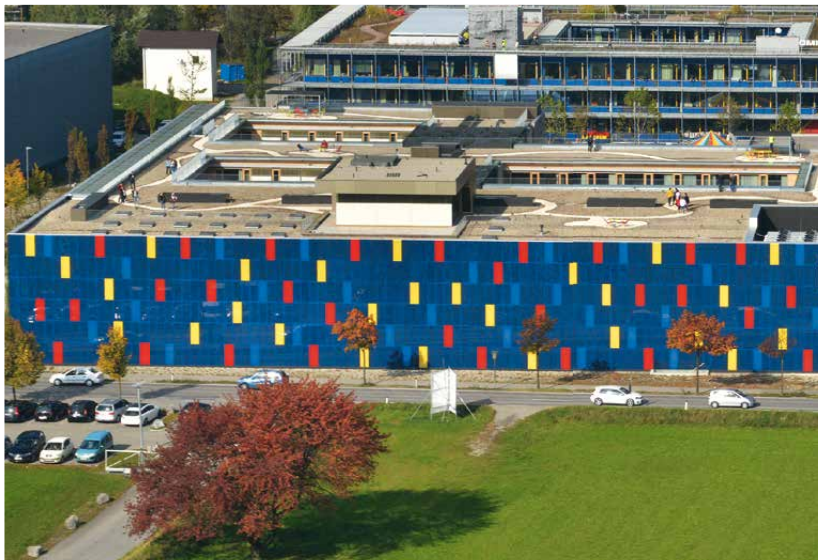
780 m<sup>2</sup> / 8,396 ft<sup>2</sup> of photovoltaic panels are installed at the frontside of OMICRON's office in Klaus.

The installation has a maximum output of 92 kW, and any surplus energy is fed into the grid. The internal low-voltage network is connected directly to the public medium-voltage grid (11 kV) via a transformer with a nominal output of 1 MVA. ▶

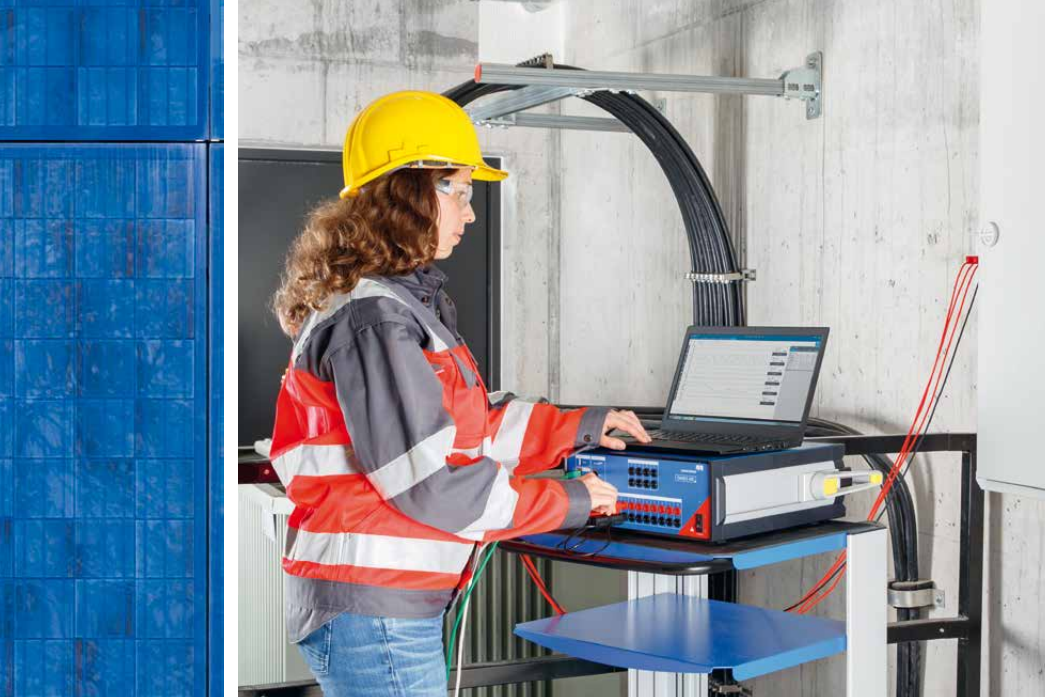
#### Testing with DANEO 400:

One of the measuring points was located directly at the transformer and the supply terminals of the energy supplier in order to detect disturbances from and into the medium-voltage grid.
